***INSPECTION AND CLEANING OF THE ROSS DRIVE
1.45-MILLION GALLON WELDED STEEL WATER STORAGE TANK***

***AMAWALK-SHENOROCK WATER DISTRICT
SHENOROCK, NEW YORK***

OCTOBER 26, 2010

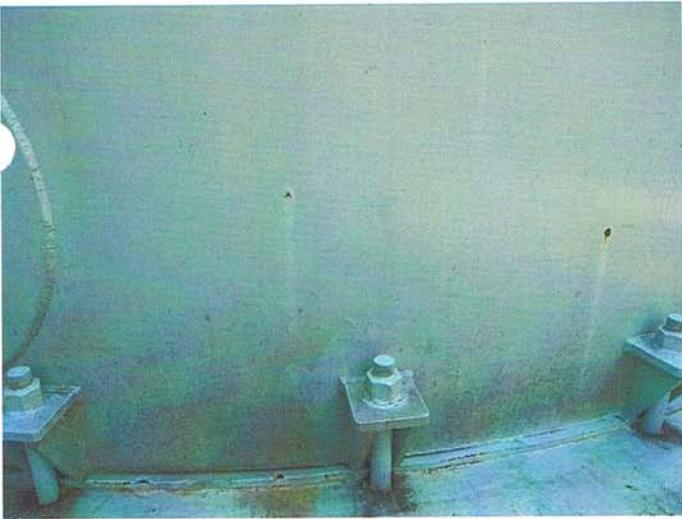
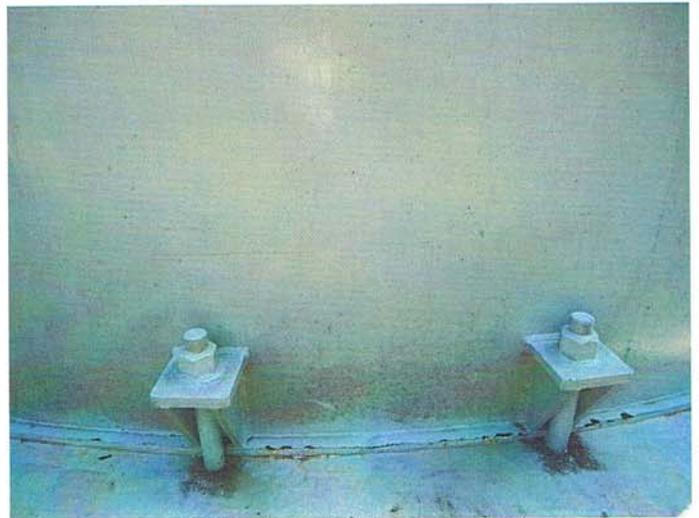
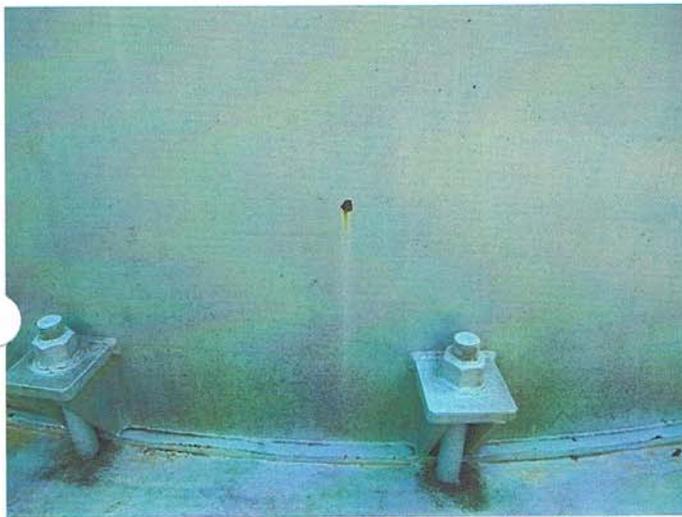
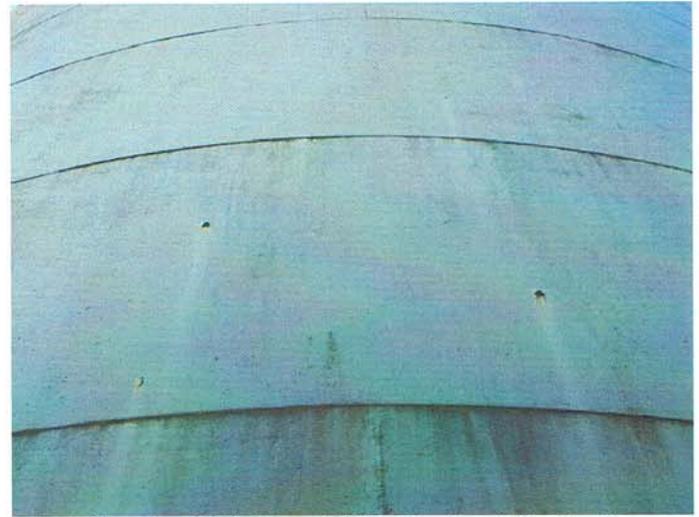
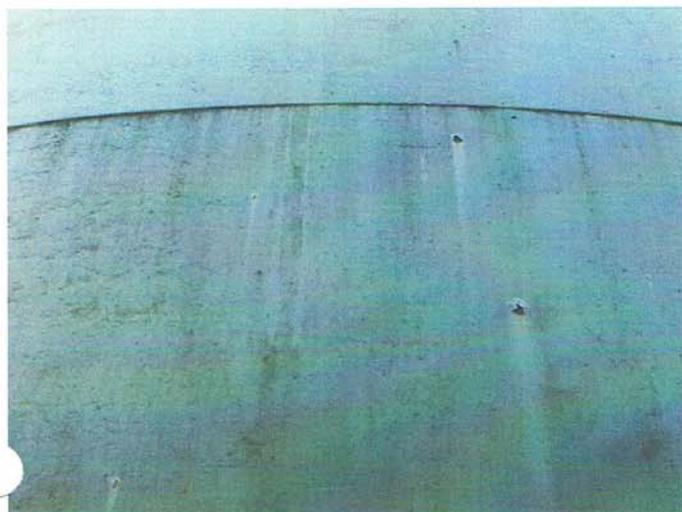
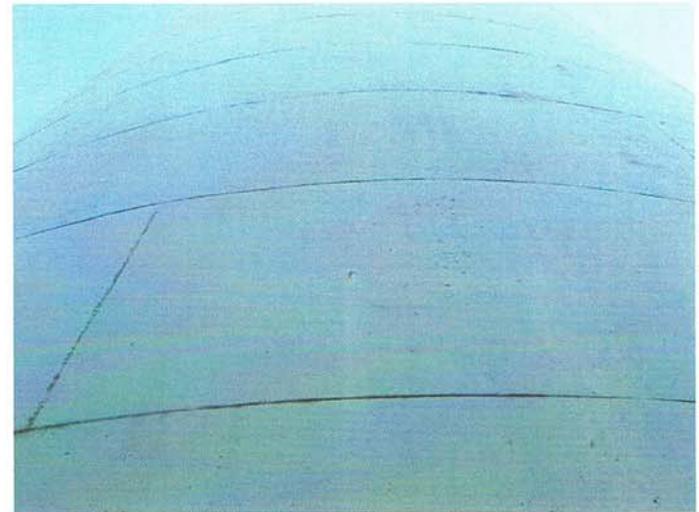
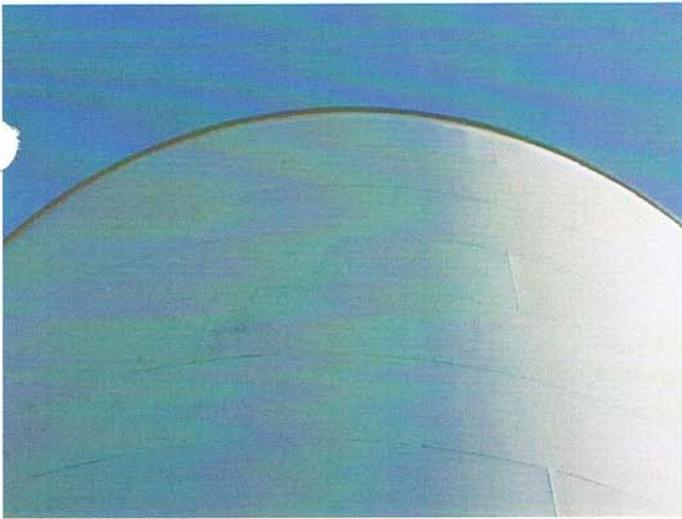
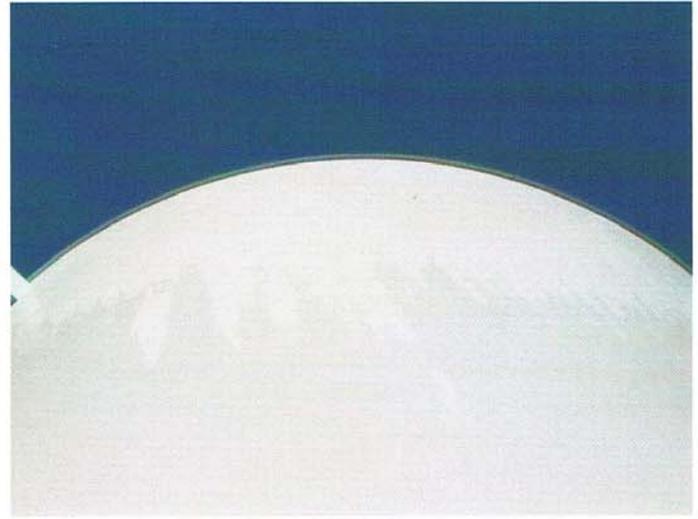
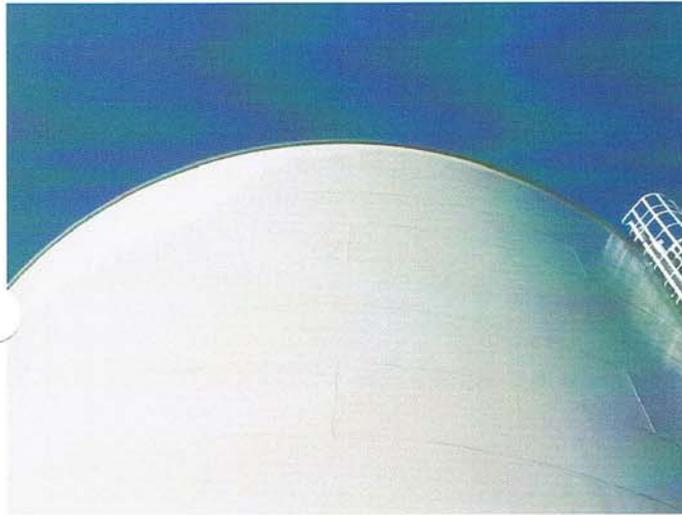
These exterior wall panels and welds were inspected and appeared mostly sound and free of obvious metal fatigue (pitting), while numerous coating chips and coating adhesion loss exists throughout these surfaces.

The protective coating has declined in film thickness (nearly expired) due to weathering, causing chalking throughout all elevations of the tank.

A 2" wide extension of the floor panels, located at the junction where the walls and foundation meet, extending out into the concrete foundation, was found with poor adhesion value of the protective coating. This condition (adhesion loss) causes exposure of the steel throughout approximately 10% of the circumference of the tank. No metal fatigue (pitting) was seen rather mild surface corrosion exists.

Numerous coating chips were found throughout approximately 5% of the lowest 24' of the tank ranging in size from 1/4" to 2" in diameter. These coating chips appear to be the result of objects (stones) striking the walls and cause exposure of the underlying steel. No metal fatigue (pitting) was seen within these areas yet mild surface corrosion exists at this time.

Mild mildew has accumulated throughout all elevations of these wall surfaces reducing the overall aesthetics of the tank.

1 *Exterior Walls Found With Coating Adhesion Loss (Nearly Expired), Coating Chips, Steel Exposure And Mildew*

2 *Exterior Walls Found With Coating Adhesion Loss (Nearly Expired), Coating Chips, Steel Exposure And Mildew*

3 *Exterior Walls Found With Coating Adhesion Loss (Nearly Expired), Coating Chips, Steel Exposure And Mildew*

4 *Exterior Walls Found With Coating Adhesion Loss (Nearly Expired), Coating Chips, Steel Exposure And Mildew*

5 *Exterior Walls Found With Coating Adhesion Loss (Nearly Expired), Coating Chips, Steel Exposure And Mildew*

6 *Exterior Walls Found With Coating Adhesion Loss (Nearly Expired), Coating Chips, Steel Exposure And Mildew*

7 *Exterior Walls Found With Coating Adhesion Loss (Nearly Expired), Coating Chips, Steel Exposure And Mildew*

8 *Exterior Walls Found With Coating Adhesion Loss (Nearly Expired), Coating Chips, Steel Exposure And Mildew*

9 *Exterior Walls Found With Coating Adhesion Loss (Nearly Expired), Coating Chips, Steel Exposure And Mildew*

We recommend re-coating all exterior surfaces of this tank in an effort to halt corrosion, protect the steel and maintain the integrity of the structure.

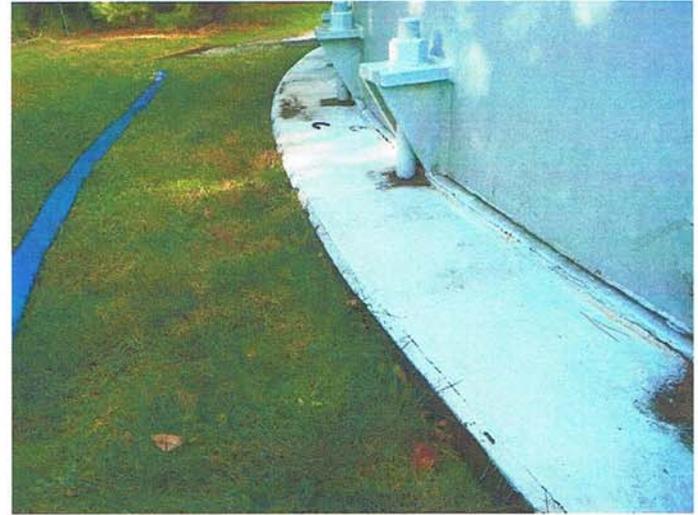
10 *Concrete Foundation*

A 5" tall by 20" wide concrete foundation was inspected and appeared sound while no obvious fatigue or concrete failures were seen.

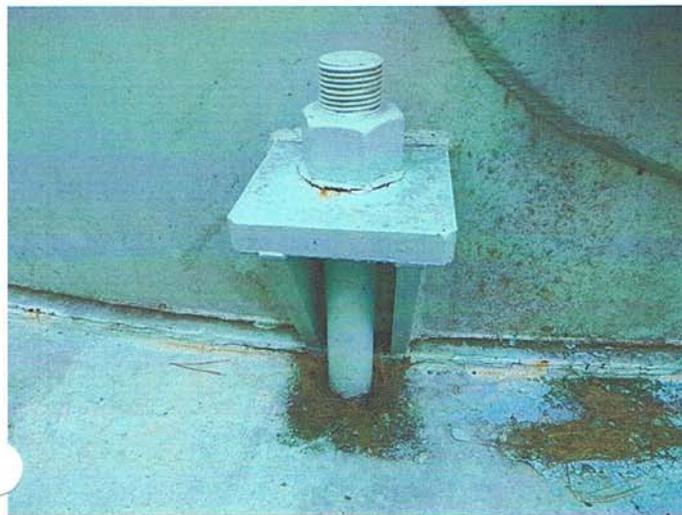
11 *One, Of Thirty-Five Anchor Bolts*

Each anchor bolt has a nut properly and securely in place, while the protective coating applied to this hardware and chairs has failed. This coating failure causes cracking of the coating, yet no obvious steel fatigue was seen, rather rust staining and mild corrosion exists.

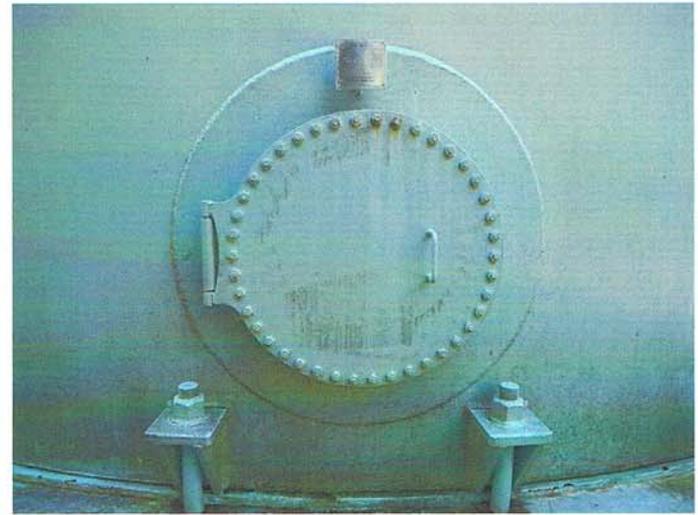
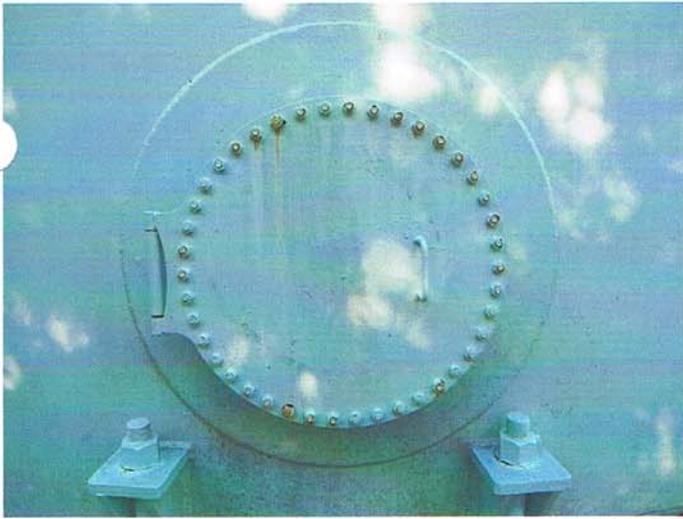
The protective coating remains having mostly good adhesion value, yet blotch rusting shows through the coating on all the hardware (nuts and bolts) used to secure these manways.

Each manway is properly secured in place and free of obvious leakage at this time.

12 *Manway*

13 *Manway*

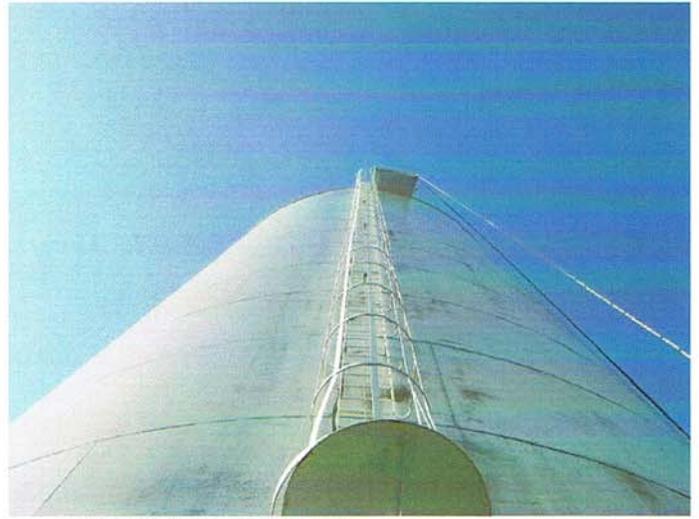
14 *Ladder And Safety Cage*

The protective coating has declined in film thickness (nearly expired) due to weathering, causing chalking yet no exposed steel was seen.

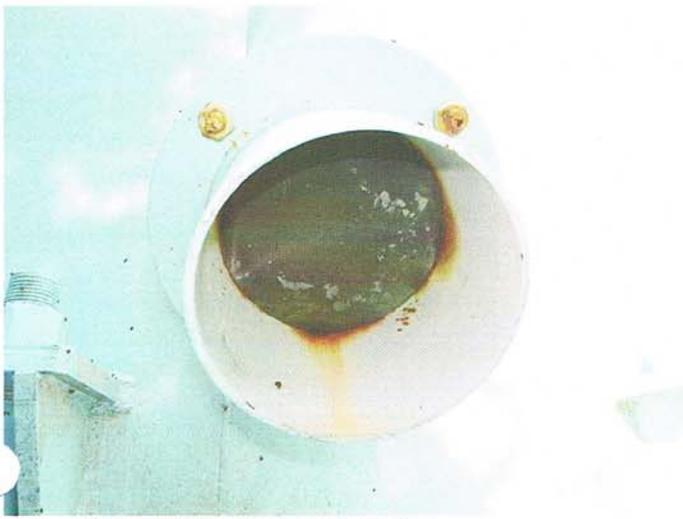
This overflow pipe is screened at its end, preventing access to the interior of the tank.

17 *Screened End Of Overflow Pipe*

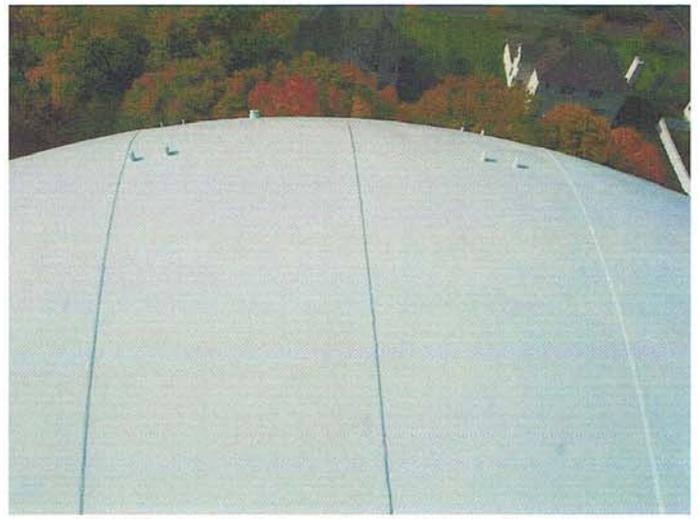
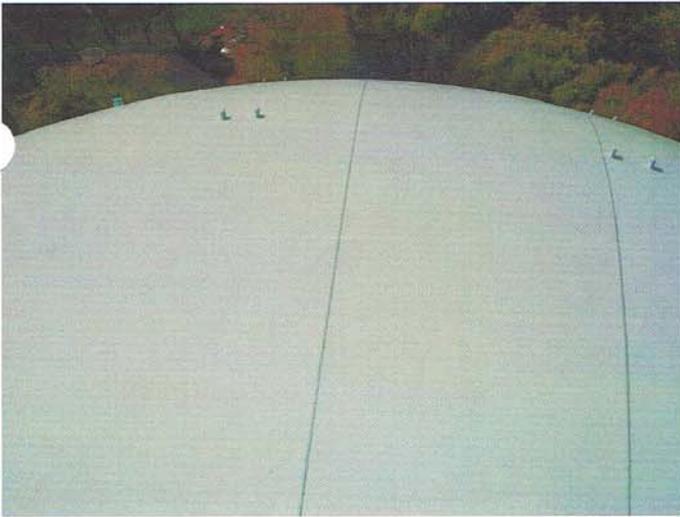
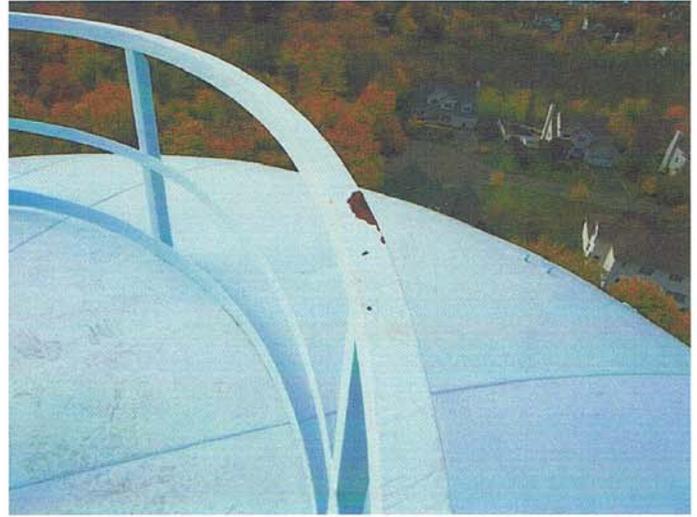
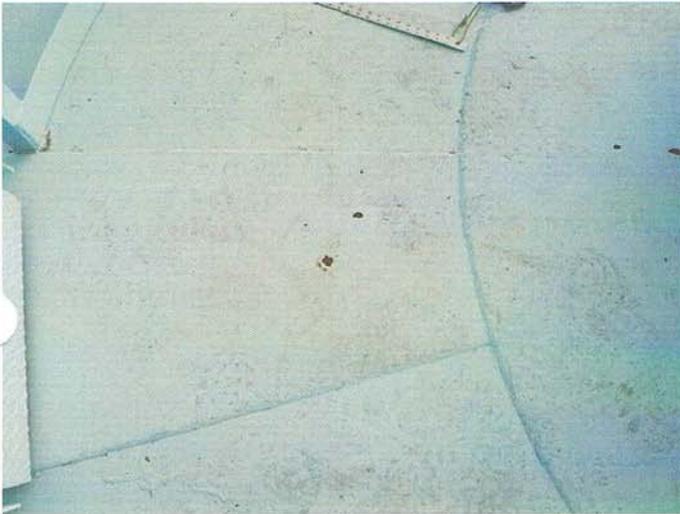
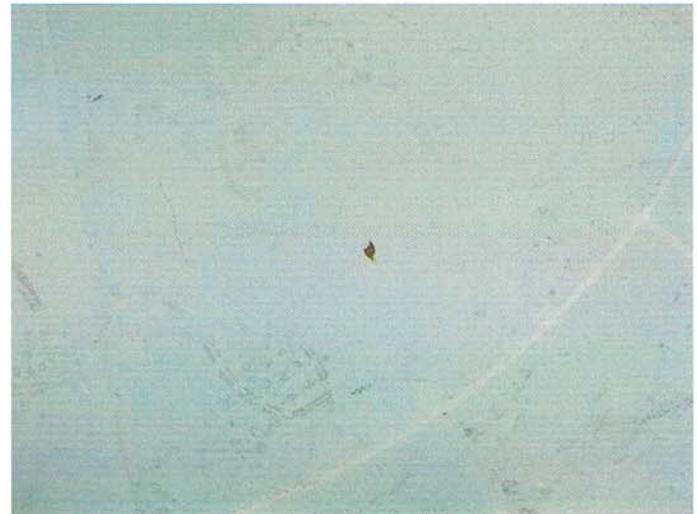
The protective coating applied to these surfaces was found with poor adhesion value, causing the protective coating to peel and exposes the steel throughout approximately 5% of all panels and angle iron safety rails.

18 *Roof Dome Panels, Welds And Angle Iron Safety Rails Found With Coating Failure And Steel Exposure*

19 *Roof Dome Panels, Welds And Angle Iron Safety Rails Found With Coating Failure And Steel Exposure*

20 *Roof Dome Panels, Welds And Angle Iron Safety Rails Found With Coating Failure And Steel Exposure*

21 *Roof Dome Panels, Welds And Angle Iron Safety Rails Found With Coating Failure And Steel Exposure*

22 *Roof Dome Panels, Welds And Angle Iron Safety Rails Found With Coating Failure And Steel Exposure*

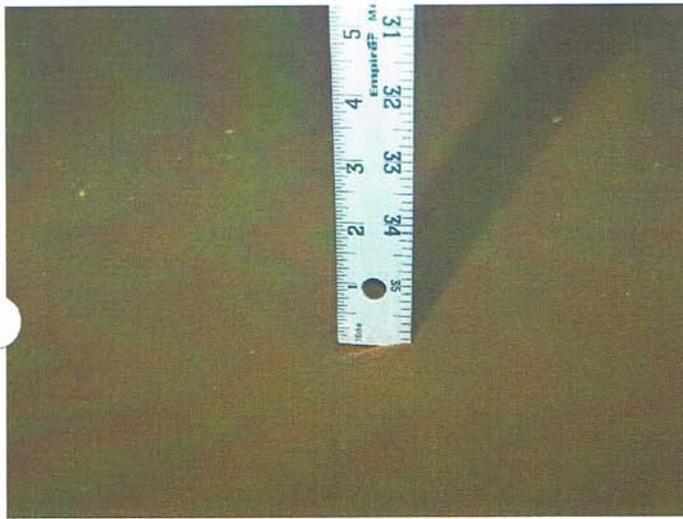
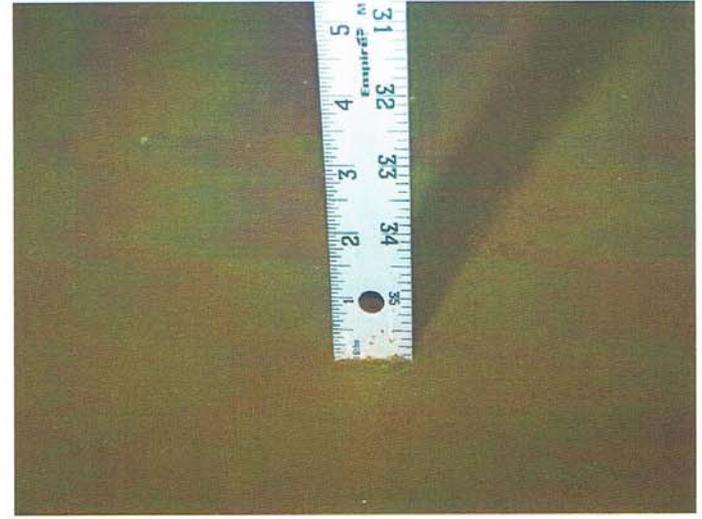
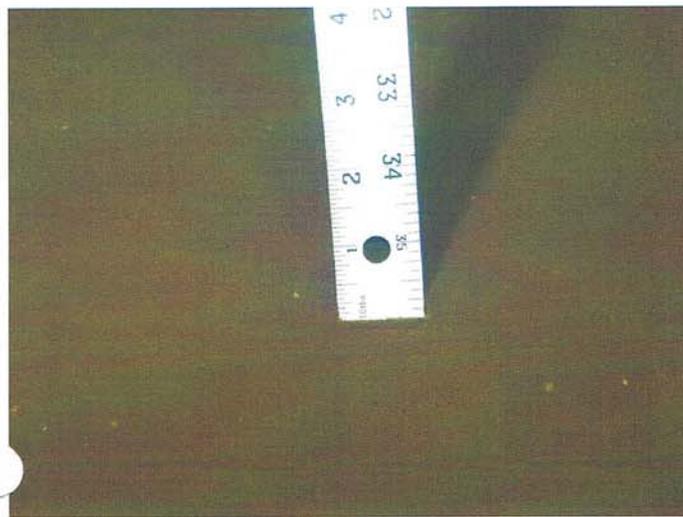
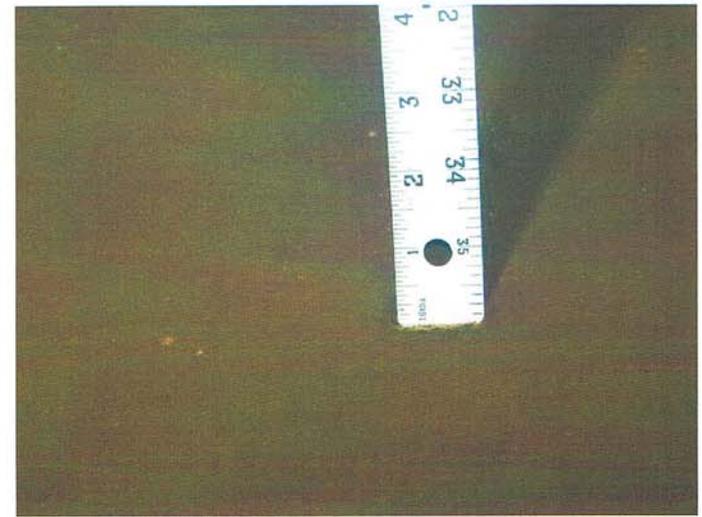
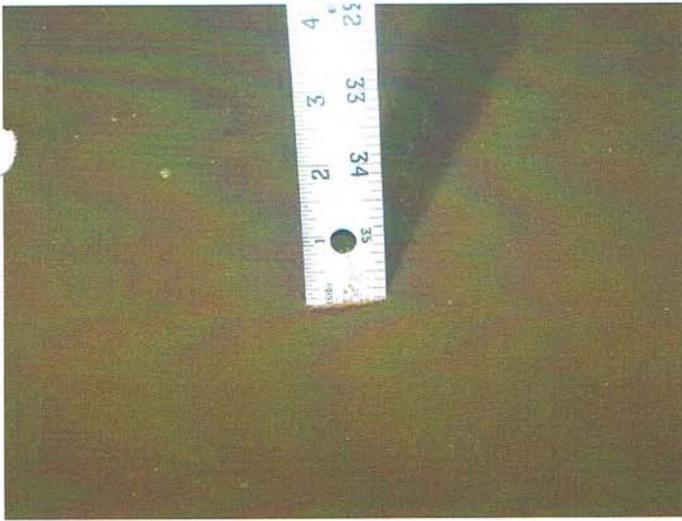
A uniform layer of accumulated precipitate was found on all floor surfaces averaging 1/16" in depth.

27 *Layer Of Precipitate*

28 *Layer Of Precipitate*

29 *Layer Of Precipitate*

30 *Layer Of Precipitate*

31 *Layer Of Precipitate*

Upon completing this inspection, all floor surfaces were vacuumed.

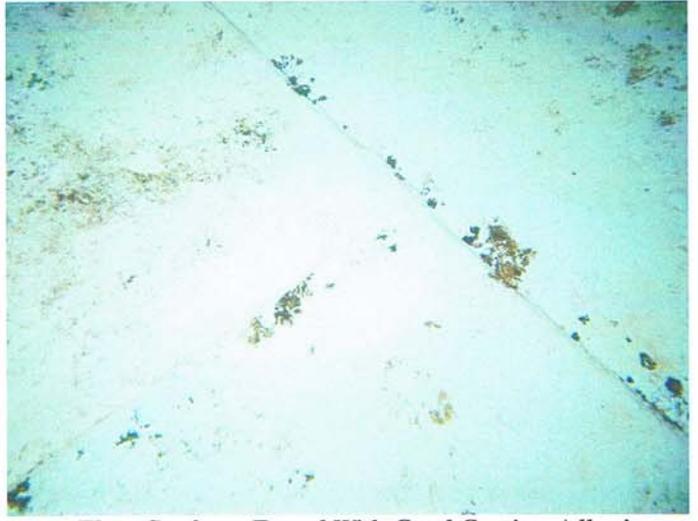
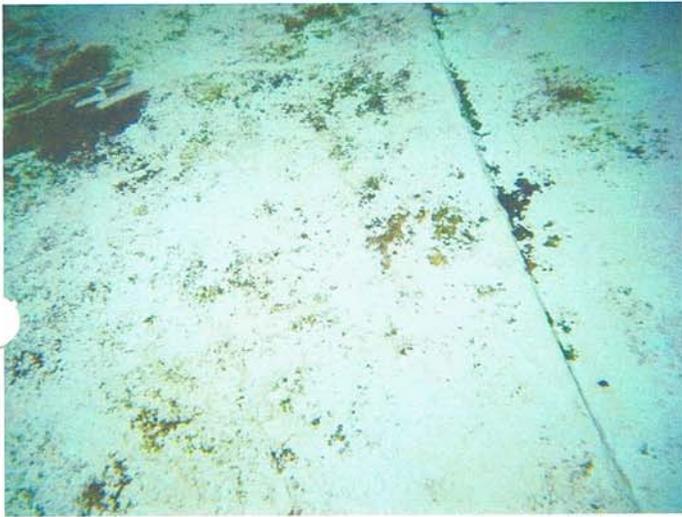
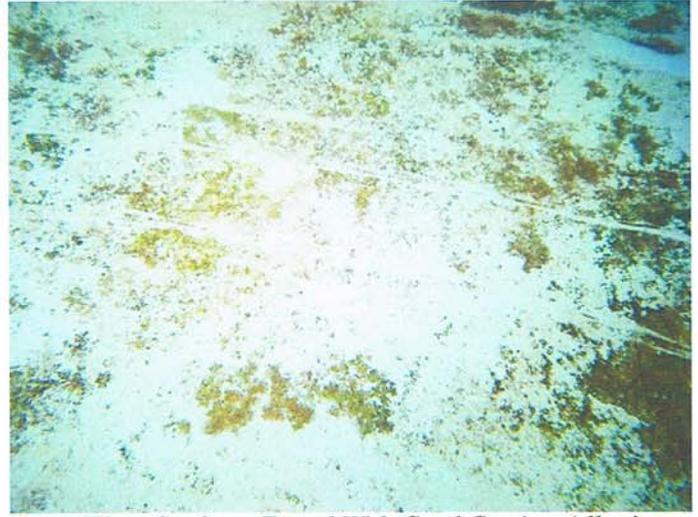
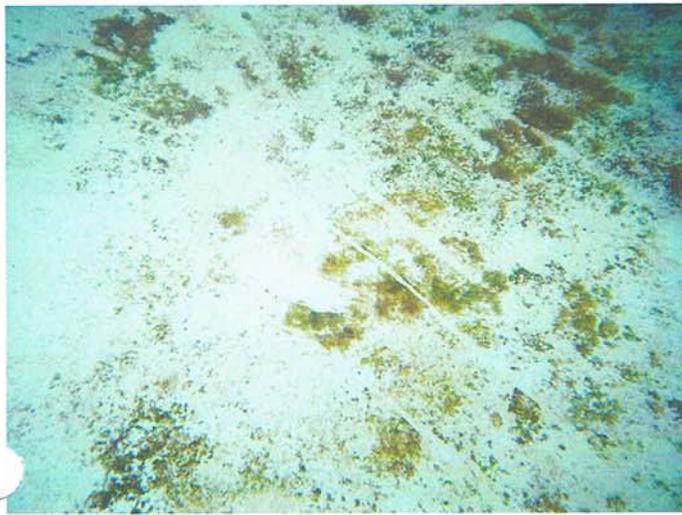
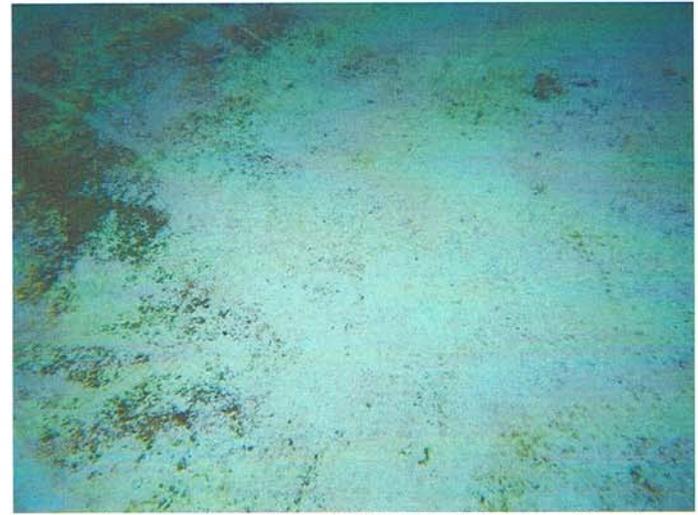
The protective coating remains having good adhesion value providing good protection of the steel.

Mild staining exists throughout all floor surfaces due to the accumulation of precipitate.

32 *Floor Surfaces Found With Good Coating Adhesion Yet Stained*

33 *Floor Surfaces Found With Good Coating Adhesion Yet Stained*

34 *Floor Surfaces Found With Good Coating Adhesion Yet Stained*

35 *Floor Surfaces Found With Good Coating Adhesion Yet Stained*

36 *Floor Surfaces Found With Good Coating Adhesion Yet Stained*

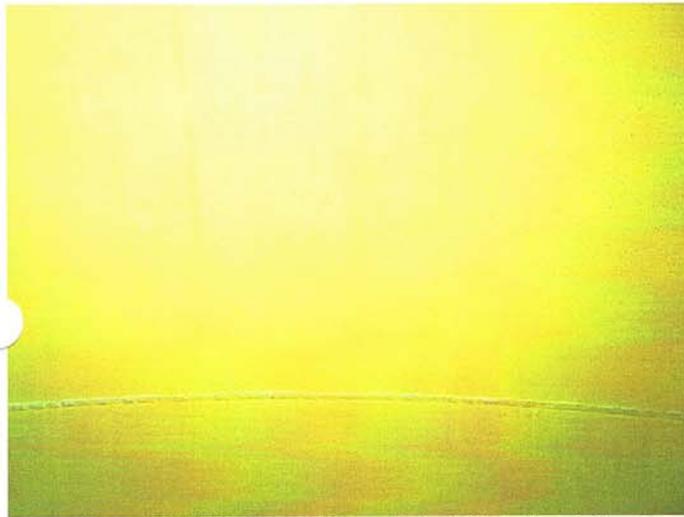
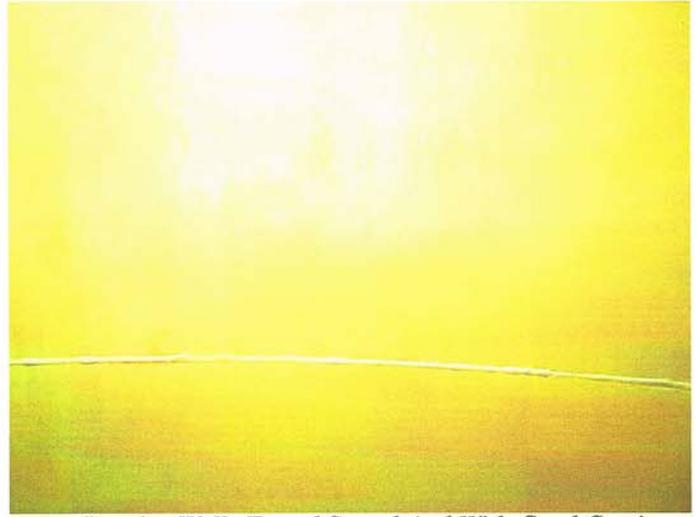
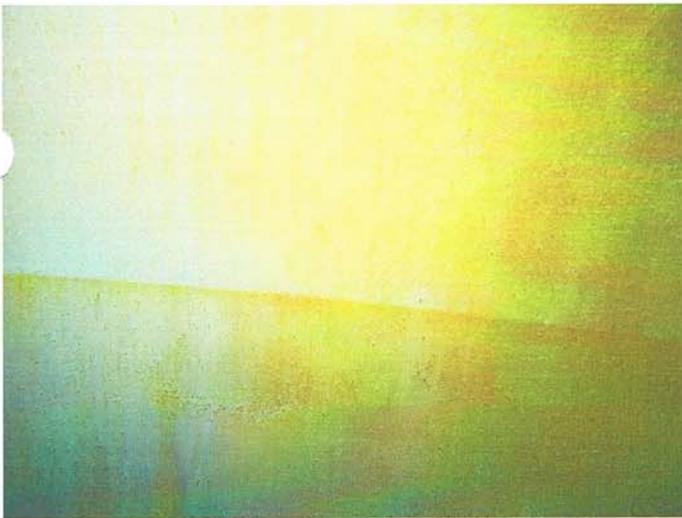
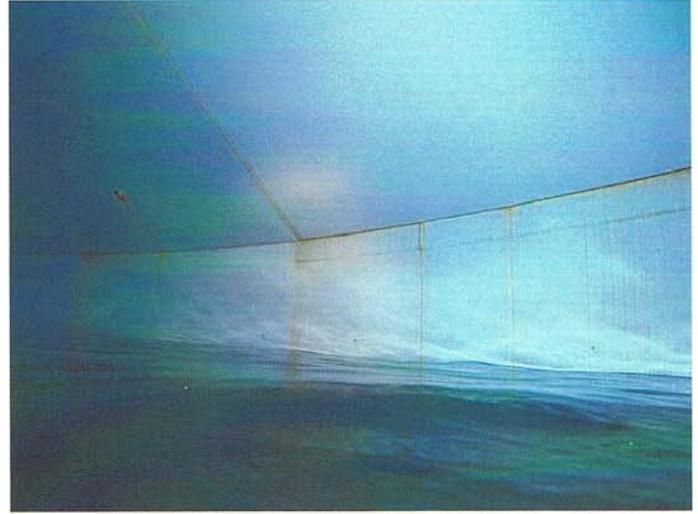
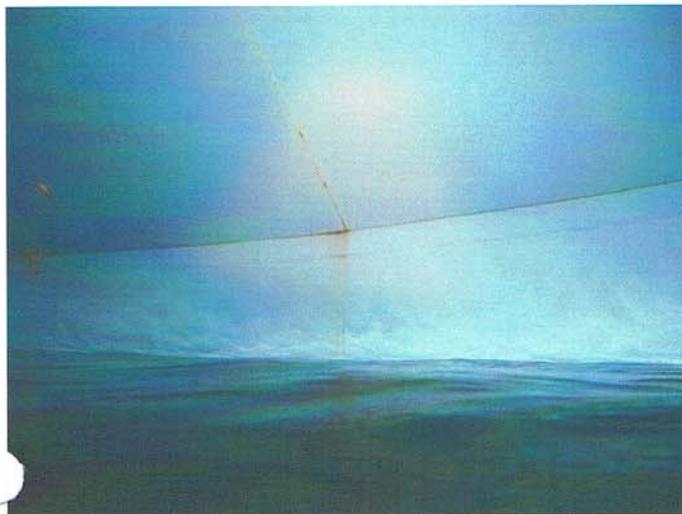
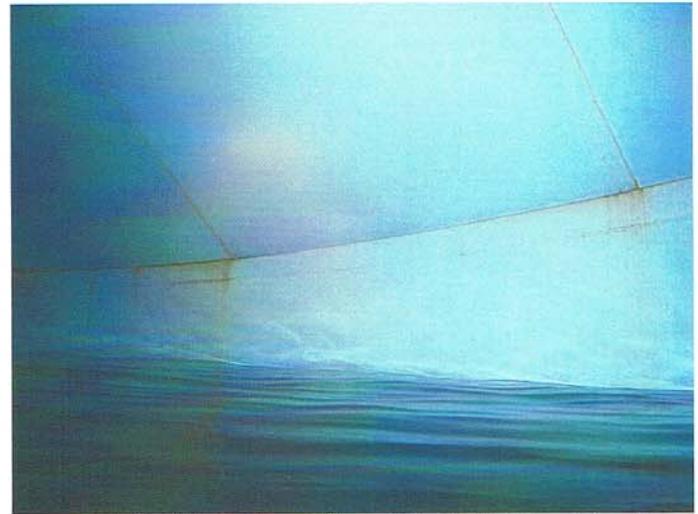
The protective coating remains having good adhesion value throughout all elevations of the tank at this time, providing good protection of the steel substrate.

Rust staining exists throughout the top row of wall panels, extending down into these surfaces from the junction where the roof and walls meet; yet no obvious steel exposure was witnessed within this area, therefore we believe the underside of the dome must yield corrosion which cannot be seen as it is not visible due to the placement and configuration of the wall panels to dome construction.

Mild staining exists on all wall surfaces extending from approximately 20" below the overflow down to the floor.

44 *Interior Walls Found Sound And With Good Coating Adhesion Yet Stained*

45 *Interior Walls Found Sound And With Good Coating Adhesion Yet Stained*

46 *Interior Walls Found Sound And With Good Coating Adhesion Yet Stained*

47 *Interior Walls Found Sound And With Good Coating Adhesion Yet Stained*

48 *Interior Walls Found Sound And With Good Coating Adhesion Yet Stained*

49 *Interior Walls Found Sound And With Good Coating Adhesion Yet Stained*

50 *Interior Walls Found Sound And With Good Coating Adhesion Yet Stained*

51 *Interior Walls Found Sound And With Good Coating Adhesion Yet Stained*

52 *Interior Walls Found Sound And With Good Coating Adhesion Yet Stained*

53 *Interior Walls Found Sound And With Good Coating Adhesion Yet Stained*

54 *Interior Walls Found Sound And With Good Coating Adhesion Yet Stained*

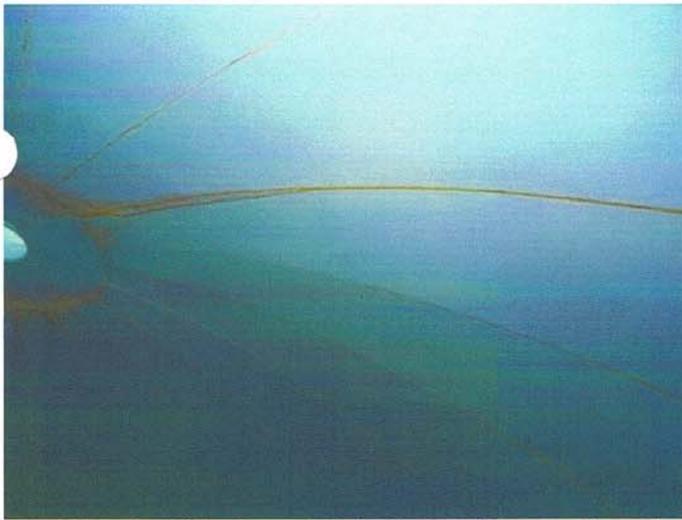
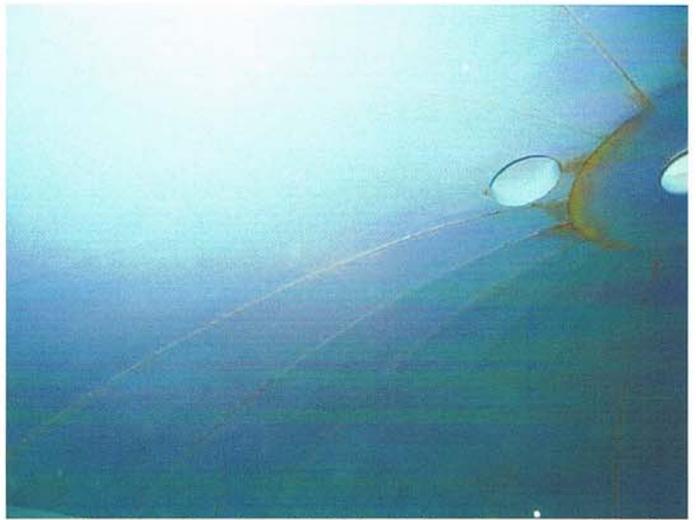
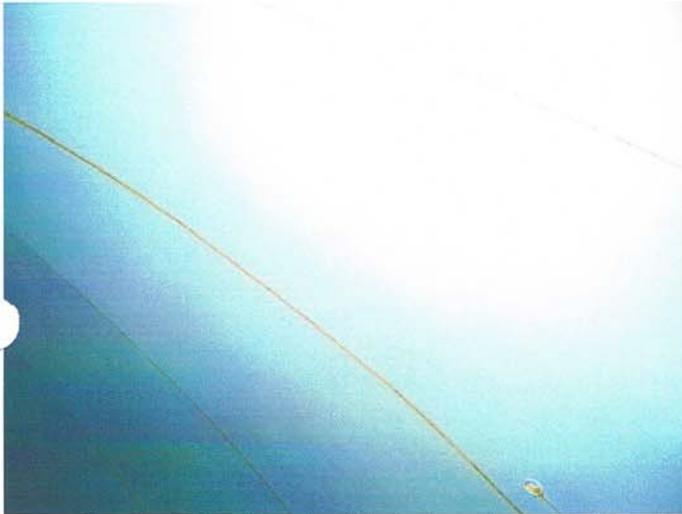
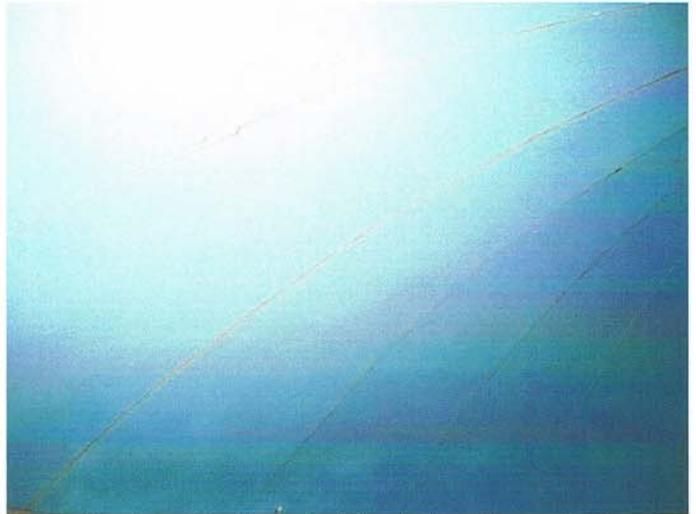
The protective coating remains with good adhesion value, yet mild blotch rusting shows through the coating throughout approximately 5% of all panel edges due to decline in film thickness of the coating.

Rust staining exists throughout each area where the seven 2" diameter penetrations (rigging holes) are placed.

55 *Overhead Surfaces And Angle Iron Supports Found With Nearly Expired Coating Causing Blotch Rusting*

56 *Overhead Surfaces And Angle Iron Supports Found With Nearly Expired Coating Causing Blotch Rusting*

57 *Overhead Surfaces And Angle Iron Supports Found With Nearly Expired Coating Causing Blotch Rusting*

58 *Overhead Surfaces And Angle Iron Supports Found With Nearly Expired Coating Causing Blotch Rusting*
